**Defects Review Bridlewood Pointe of View Project Last Update June 18/08**

**Status: June17, 2008 of the 73 Issues in the original version of this report 36 remain open. The closed issues have been deleted from the report for this update.**

This Update report contains a review of resident reported defects in the common areas of the Bridlewood Pointe of View project during the initial one year warranty period. All defects were reported to the developer Pointe of View on the residents' behalf by the board of directors for this complex within this one year period.

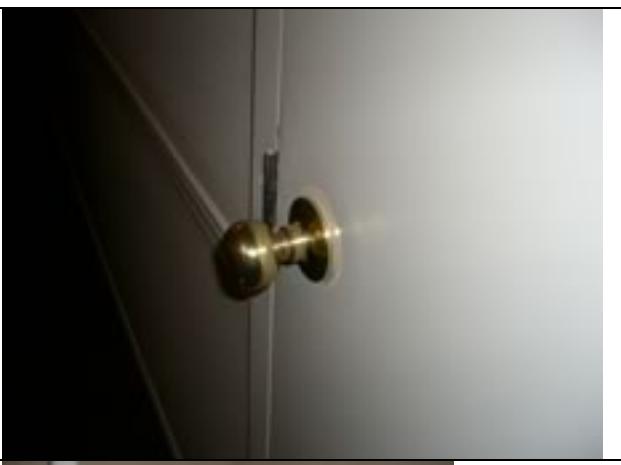
Location	Defect	Photographs
1000-2 Item#2	Doorknob and lock on Shaw Cable closet on 2 <sup>nd</sup> floor next to 1216 defective and requires replacement.  POV to Fix  Update 05/28/2008 POV replaced door knob with one with a defective lock. Requires replacement.

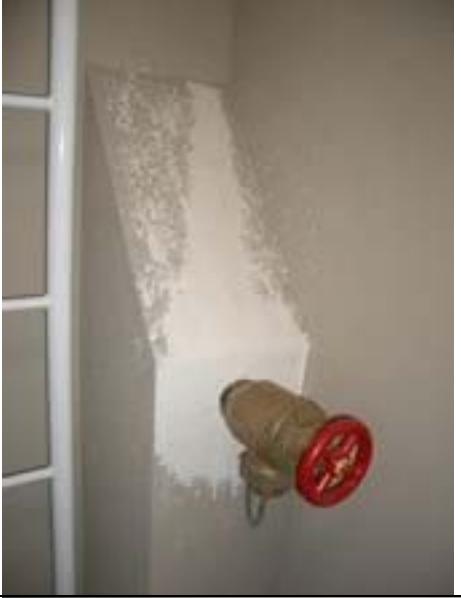
1000-4 Item#4	South Stairwell 4 <sup>th</sup> floor Fire hose outlet drywall repair unpainted.  POV to Fix  Update 05/28/2008 Not fixed.

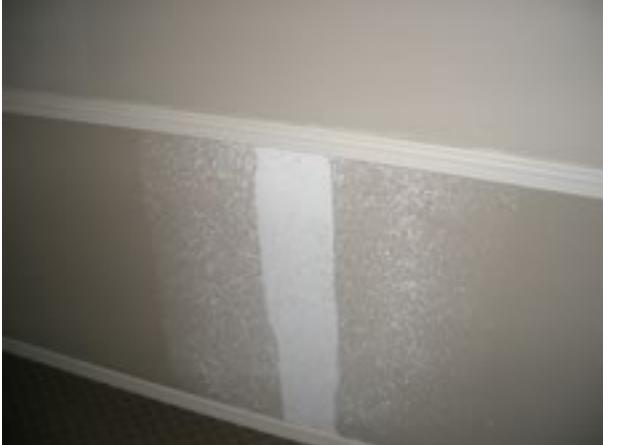
1000-4 Item#5	4 <sup>th</sup> Floor between 1414 and 1416 Drywall repair unpainted.  POV to Fix  Update 05/28/2008 Not fixed.

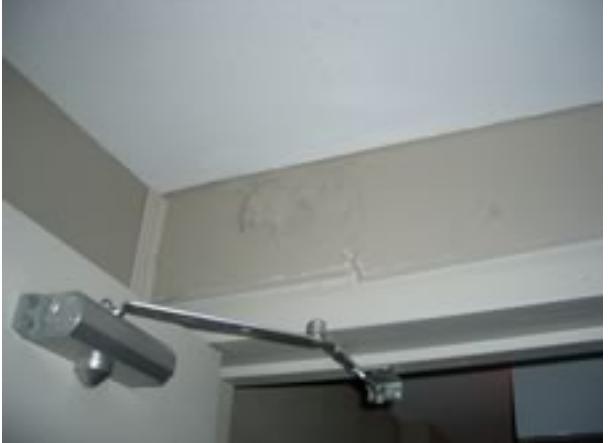
Location	Defect	Photographs
1000-4 Item#7	<p>Section of drywall cut out above fire doors in centre of building for some inexplicable reason.</p> <p>POV to Fix</p> <p>Update 05/28/2008 Not fixed.</p>

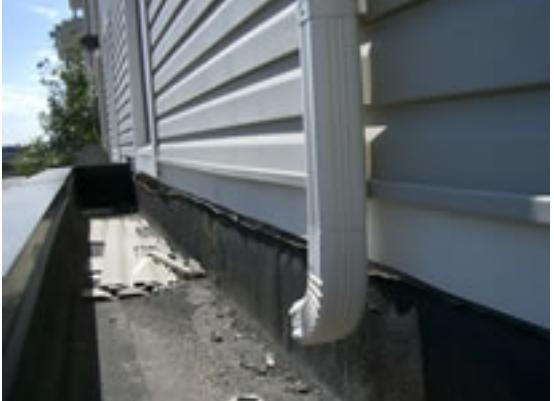
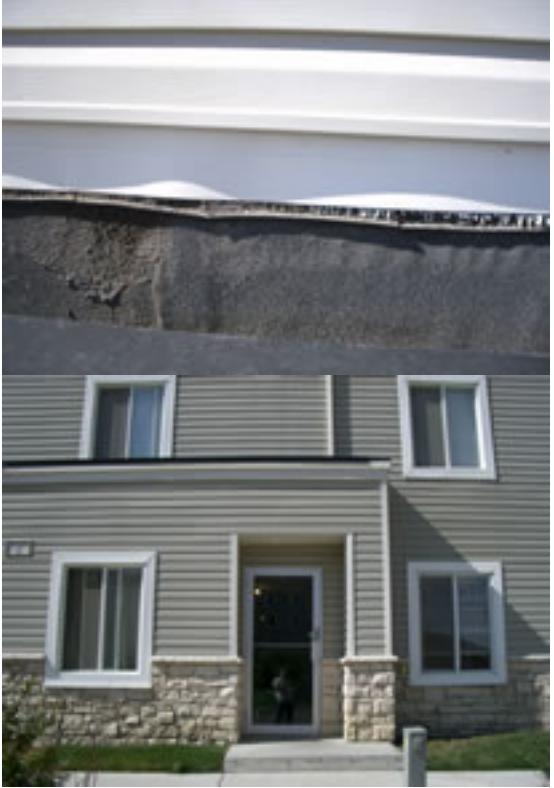
Location	Defect	Photographs
1000-M Item#65	<p>Wall Flashing showing severe peeling above Northeast and Southeast Entrance Flat Roof Areas in 1000. As well building materials from the construction phase have been left on the roof. A Piece of flashing was not installed on the NE Corner of the NE Entrance Flat Roof forward edge as well.</p> <p><b>Eng.Report issue RS3 section 4.2.3</b></p> <p><b>POV Comments from Eng.Report:</b> This is considered a maintenance issue that should have been scheduled for repair by the Condo Corporation/Board.</p> <p><b>Board Comments:</b> Cannot agree, building materials are left over from construction and the flashing should not be showing severe peeling in the first year. The materials need to be removed and the flashing repaired - potential water penetration here.</p> <p>Update 05/28/2008 Not fixed. Updated 06/18/2008 Excess building materials have been removed have the flashing problems have not been corrected.</p>	<p>NE Entrance Roof</p>

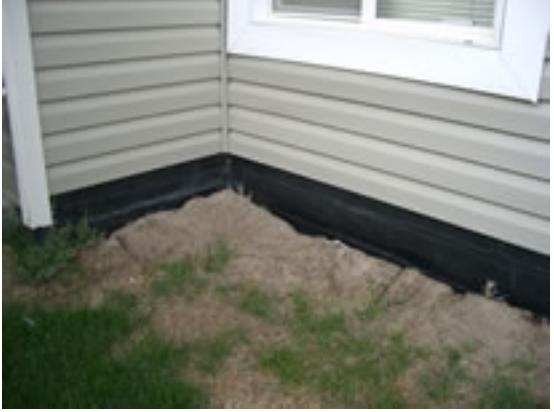
Location	Defect	Photographs
1000-M Item#66	<p>Exposed Wall Flashing at Wall Base West side 2<sup>nd</sup> patio west of building firewall. New photo confirms not fixed.</p> <p><b>Eng. Report Item #EC13</b></p> <p><b>POV Comments from Eng.Report: Scheduled to be repaired.</b></p> <p>Update 05/28/2008</p> <p>Not fixed. Parging at numerous spots around the buildings was never done. This is one of the worst examples.</p>

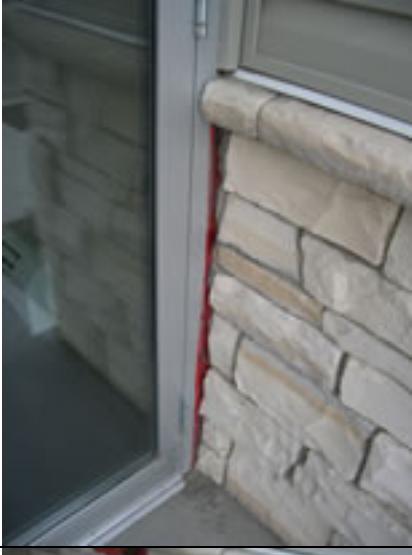
1000-M Item#67	<p>Red Tuck tape exposed at South East Entrance.</p> <p><b>POV Comments from Eng.Report: Scheduled to be repaired.</b></p> <p><b>Eng. Report Item#EC14</b></p> <p>Update 05/28/2008</p> <p>Not fixed.</p>

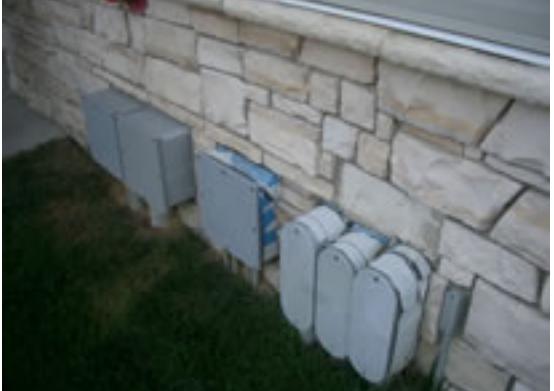
1000-M Item#68	<p>Sloppy Flashings Around service Penetrations</p> <p>Building 1000, north of main entrance door.</p> <p><b>Eng. Report Item#EC15</b></p> <p><b>POV Comments from Eng.Report: Scheduled to be repaired.</b></p> <p>Update 05/28/2008</p> <p>Not fixed.</p>

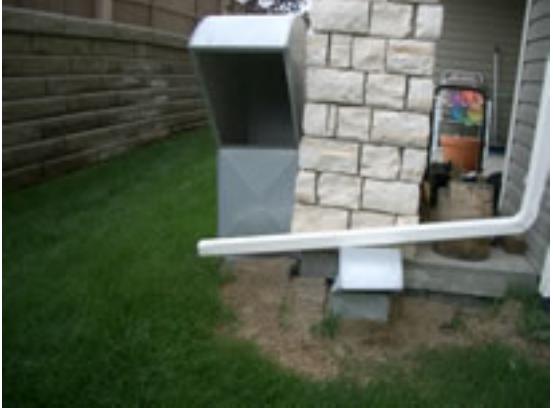
Location	Defect	Photographs
1000-M Item#70	<p>Combustion Air Ducting damaged.</p> <p><b>Eng.Report Item#M10</b></p> <p>Update 05/28/2008</p> <p>Not fixed.</p>

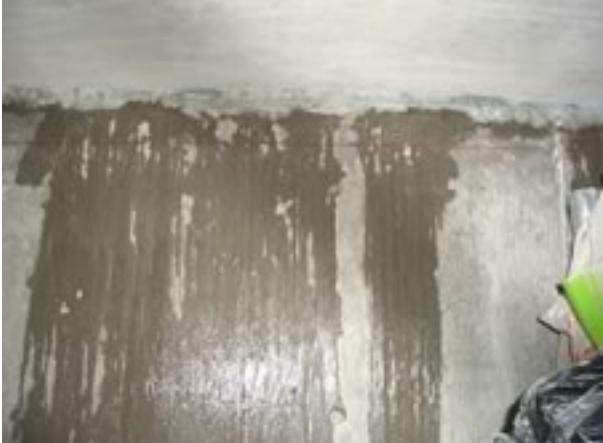
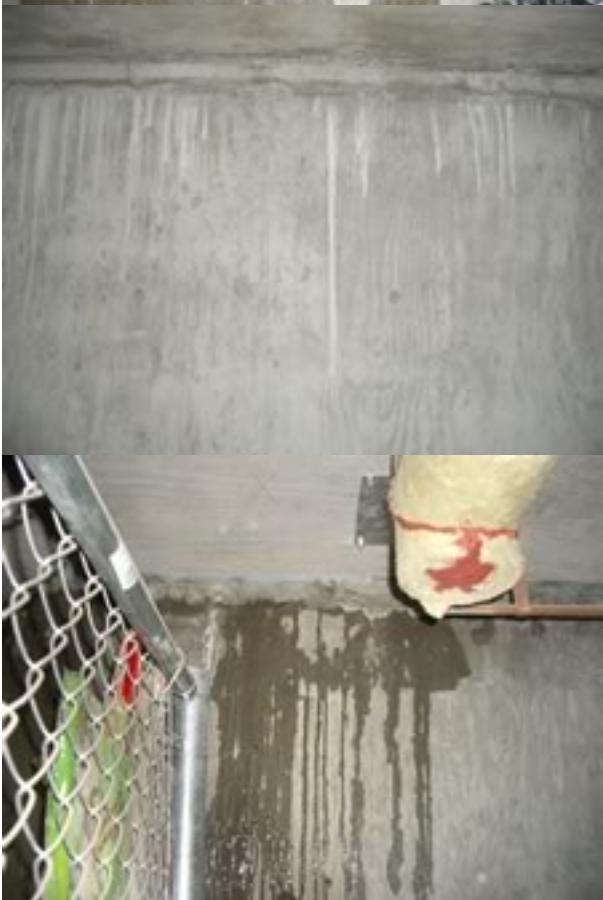
Location	Defect	Photographs
1000-P Item#11	<p>Leakage of water through parkade walls in Building 1000 resulted in flooded parkade during first few months of occupancy. Promised repairs after major flood have not been undertaken. Concrete bib adjoining top of wall not sealed correctly.</p> <p>POV to Fix</p> <p>Update 05/28/2008 Not fixed. We experienced again this spring severe leakage through this wall.</p>

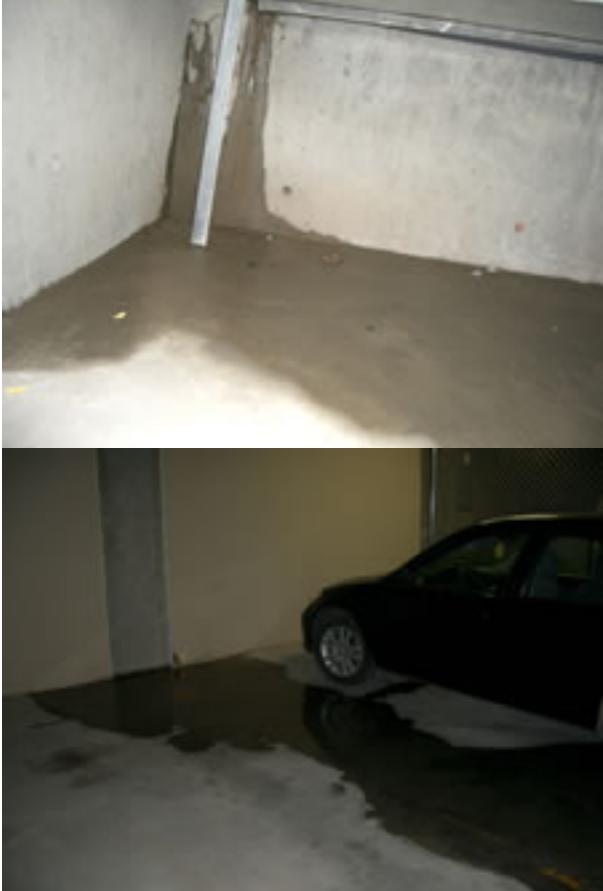
Location	Defect	Photographs
1000-P Item#12	<p>Serious water leakage on wall in SW Corner behind Air Exchanger Unit (MUA) in Parkade. Resulting standing water is damaging drywall in storage unit wall. This leak occurs every rain and was supposed to have been fixed a year ago, clearly it was not.</p> <p><b>POV to Fix</b></p> <p>Update 05/28/2008 Not fixed. We experienced again this spring severe leakage through this wall.</p>

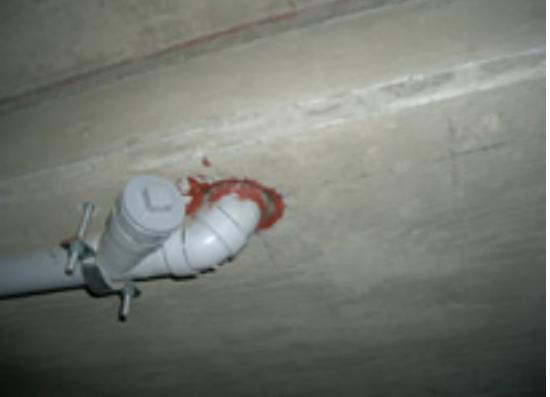
1000-P Item#17	<p>Fire rated protection missing from some piping penetrations in 1000 between the parkade and suites above. Fire rated compounds and Fire related sleeves to provide 1 hour fire separation. <b>This is a serious code violation.</b></p> <p><b>Eng. Report issue FLS6 section 11.5.3</b></p> <p><b>This concern also to the mechanical rooms in all 3 buildings as identified in the Eng. Report. See the report for more information.</b></p> <p><b>O-Ring – See comment POV response in Eng. Report.</b></p>

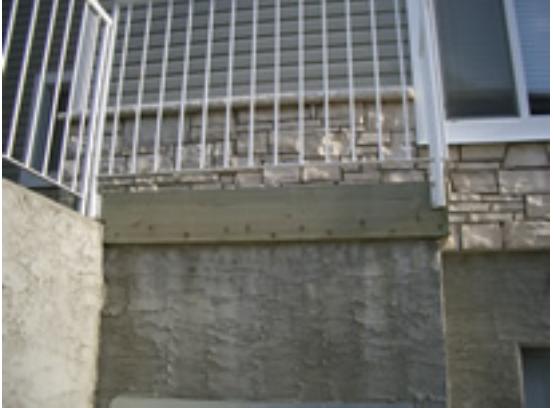
Location	Defect	Photographs
1000-P Item#18	<p>Above Parkade Entrance Fascia Wood unfinished. Wood should be stained or painted for protection.</p> <p>POV to fix (paint).</p> <p>Update 05/28/2008 Not fixed. Exposed unprotected wood.</p>

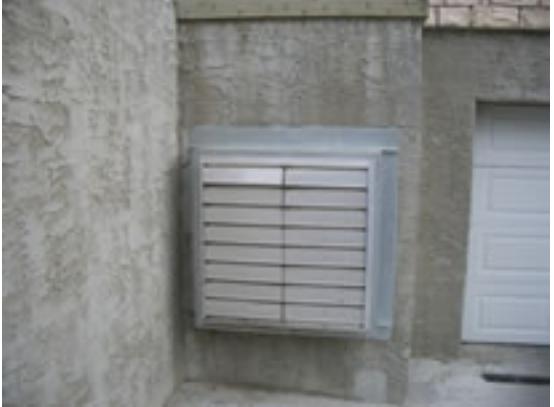
Location	Defect	Photographs
1000-P Item#71	<p>Parkade exhaust fans are missing outlet hoods are result water leakage is occurring in Parkade.</p> <p><b>Eng Report Item #M17</b></p> <p>Update 05/28/2008</p> <p>Not fixed. We experienced again this spring leakage through these units.</p>	<p>1000 Parkade Missing Hoods</p>

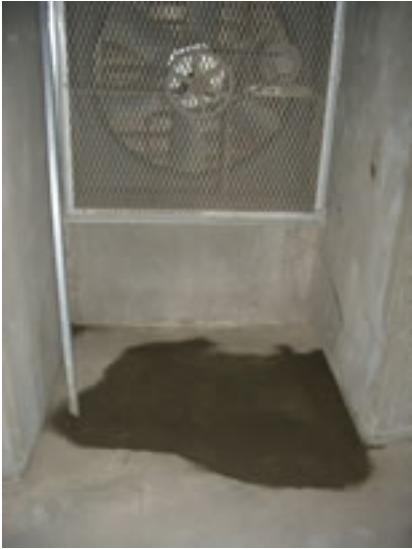
<p>1000 Parkade Leakage due to missing hoods</p>

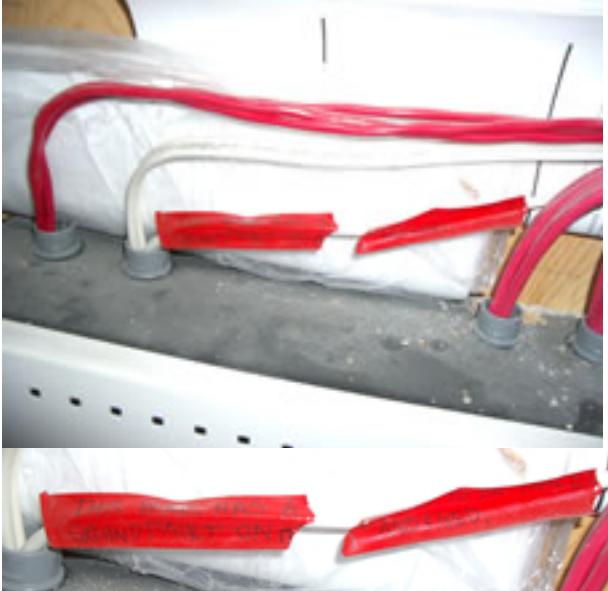
Location	Defect	Photographs
2000-2 Item#23	<p>Electrical Closet next to Suite 2213 has AC supply with an identified Ground Fault that has not been repaired. <b>This is a code violation and a Fire Hazard.</b></p> <p><b>POV to Review</b></p> <p>Update 05/28/2008 Not fixed.</p>

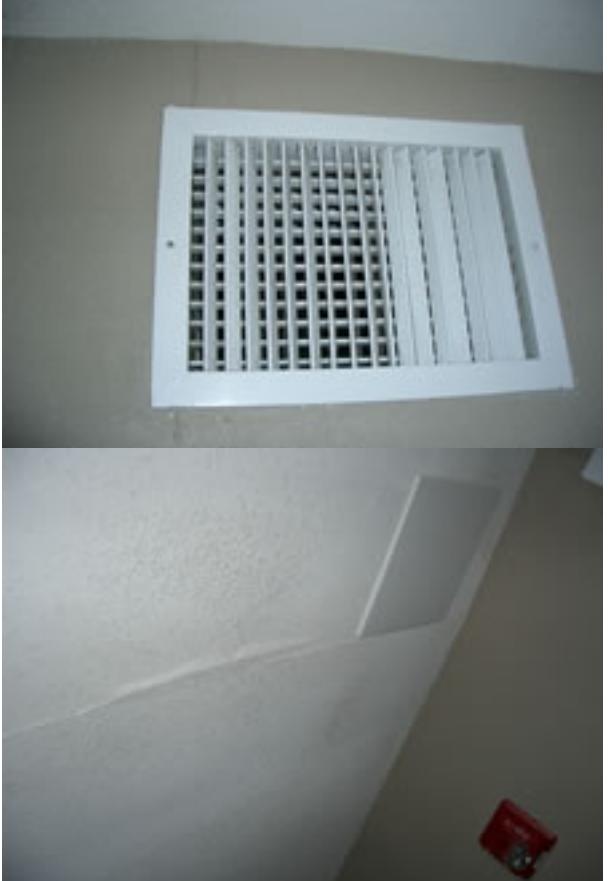
2000-2 Item#24	<p>Drywall bulges behind Fan grill on ceiling near suite 2212, many other such examples of defective drywall work in building 2000.</p> <p><b>POV to provide report and fix.</b></p> <p>Update 05/28/2008 Not fixed. Severe bulging in drywall repairs, work completely unacceptable. POV Manager (Sean McInnis) comment was that it looks it was just caulked instead of fixed properly throughout the building.</p>

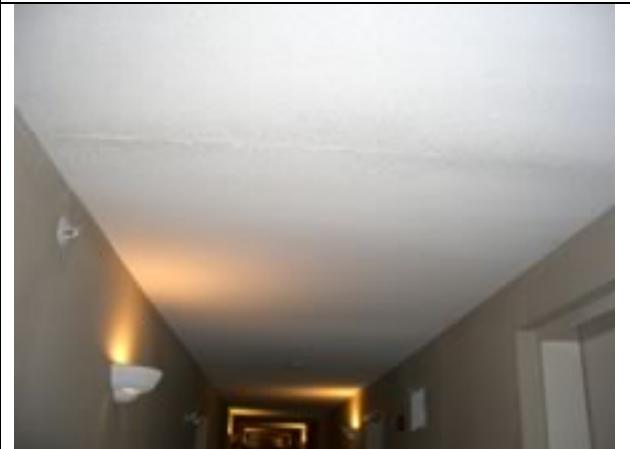
Location	Defect	Photographs
2000-4 Item#27	<p>Across from the elevator on the 4<sup>th</sup> floor a large ripple runs across of the width of ceiling and numerous other places in 2000.</p> <p><b>POV to Report on Drywall Issues and Fix.</b></p> <p>Update 05/28/2008</p> <p>Not fixed. Severe bulging in drywall repairs, work completely unacceptable. POV Manager (Sean McInnis) comment was that it looks it was just caulked instead of fixed properly throughout the building.</p>

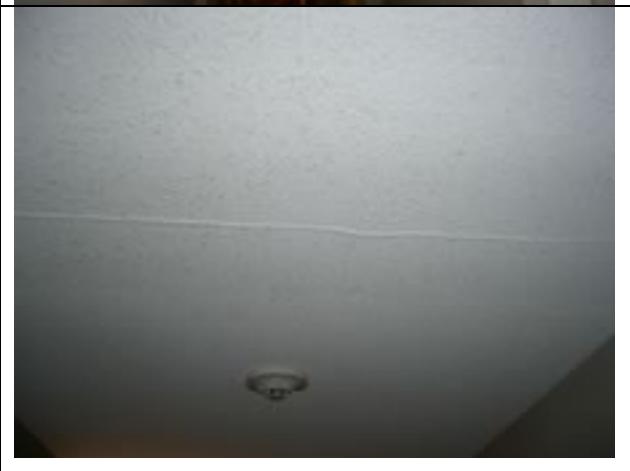
2000-All Item#30	<p>Drywall repairs are unacceptable. Joints are severely bulged and numerous large ripples exist in the ceilings and walls. Walk around inspection with POV rep, and board member required.</p> <p><b>POV to Report on Drywall Issues and Fix.</b></p> <p>Update 05/28/2008</p> <p>Not fixed. Severe bulging in drywall repairs, work completely unacceptable. POV Manager (Sean McInnis) comment was that it looks it was just caulked instead of fixed properly throughout the building.</p>

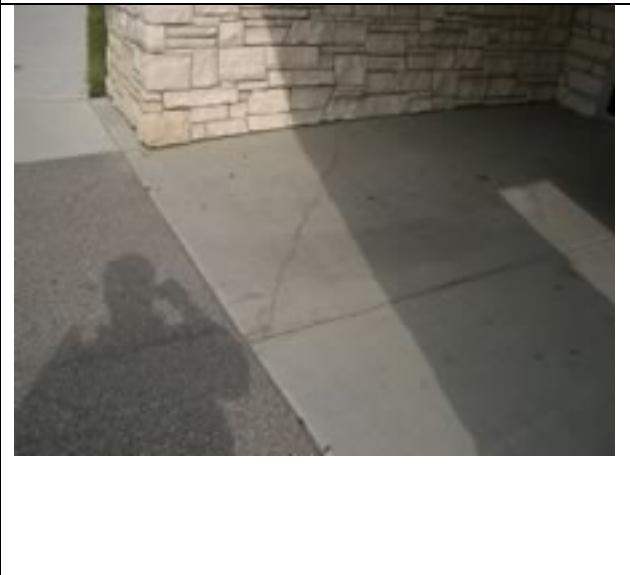
2000-M Item#33	<p>Large crack and subsidence on main entrance lobby area and concrete walkway. Sinking entryway and having lobby concrete floor.</p> <p><b>Concrete?</b></p> <p>Update 05/28/2008</p> <p>Not fixed. Critical Cracks in all underlying concrete in the front entryway and lobby indicate there may be a serious structural defect here. Since originally reported the front entryway has sunk a centimetre and the lobby concrete floor has experienced very severe heaving and risen up in the center of the lobby. It appears water now be seeping in through this heave. This is a very severe issue affecting floor integrity that needs immediate attention.</p>

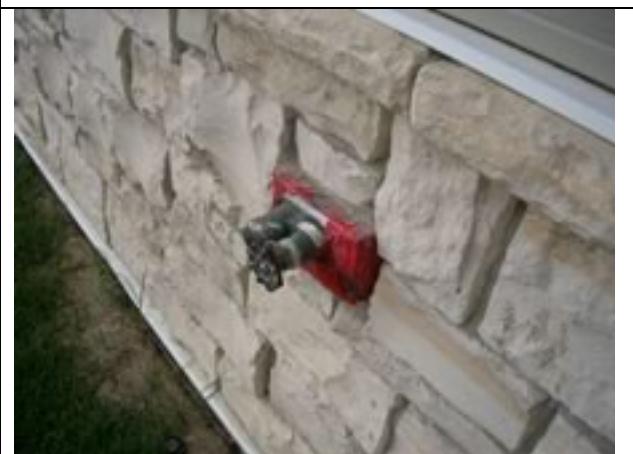
Location	Defect	Photographs
2000-M Item#35	<p>Tap installation by East and West Entrances of 2000 is unfinished, trim not installed.</p> <p>Also reported in Eng. Report Item EC-8.</p> <p><b>POV Service to Review</b></p>

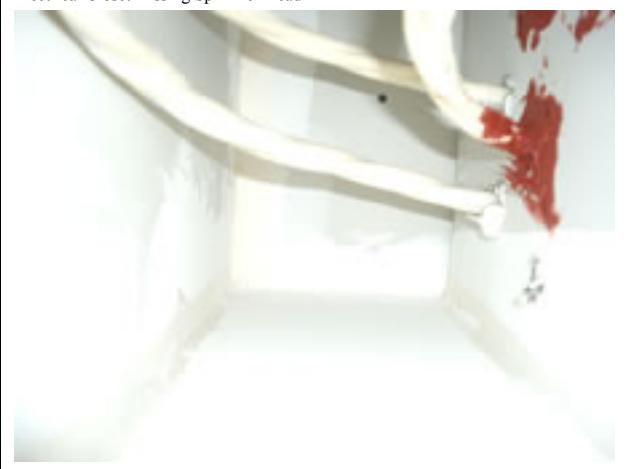
3000-2 Item#40	<p>Fire Sprinkler head never installed in Electrical Closet next to Suite 3221. It looks like the hole for the sprinkler head was plastered over.</p> <p><b>Potential Fire Code Violation</b></p> <p><b>POV to Fix</b></p> <p>Update 05/28/2008 Not fixed.</p>	<p>Electrical Closet missing Sprinkler Head</p>

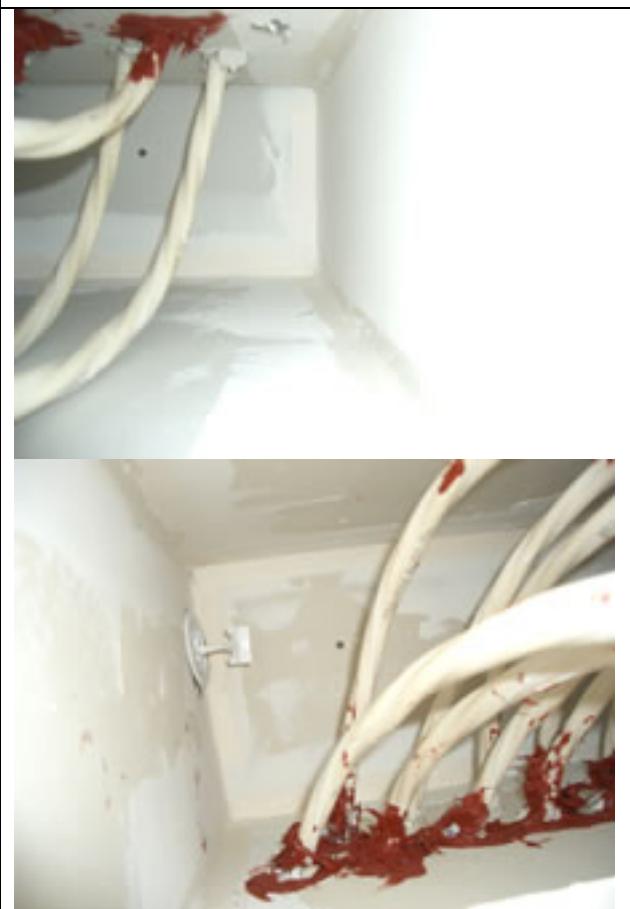
Location	Defect	Photographs
3000-2 Item#41	<p>Spotty Fire Insulation in Electrical Closet, not all wires have fire insulation. Others have insulation poorly applied resulting in very incomplete coverage.</p> <p><b>This is a Fire Hazard and possible Code Violation.</b></p> <p><b>POV to Fix</b></p> <p>Update 05/28/2008 POV Please report on what action taken on this.</p>

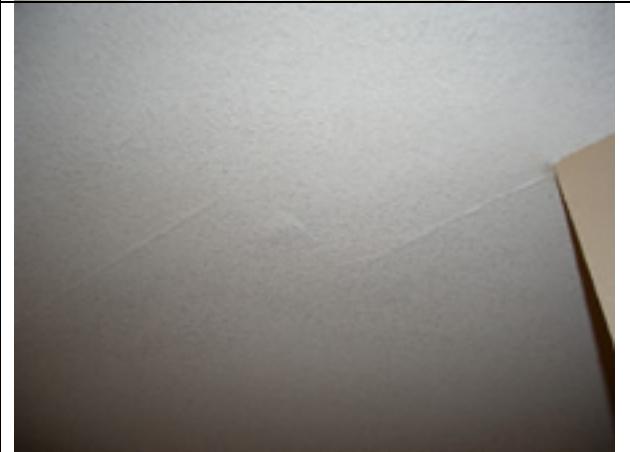
3000-4 Item#42	<p>Ceiling cracked and bulged, either repair done incorrectly or missed, next to suite 3412.</p> <p><b>POV to Report on Drywall Issues and Fix.</b></p> <p>Update 05/28/2008 Not fixed.</p>

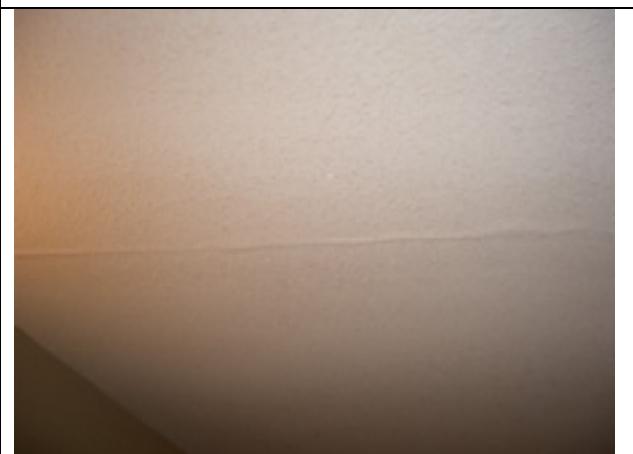
Location	Defect	Photographs
3000-4 Item#43	<p>Ceiling bulge, either repair done incorrectly or missed next to suite 3418.</p> <p><b>POV to Report on Drywall Issues and Fix.</b></p> <p>Update 05/28/2008 Not fixed.</p>

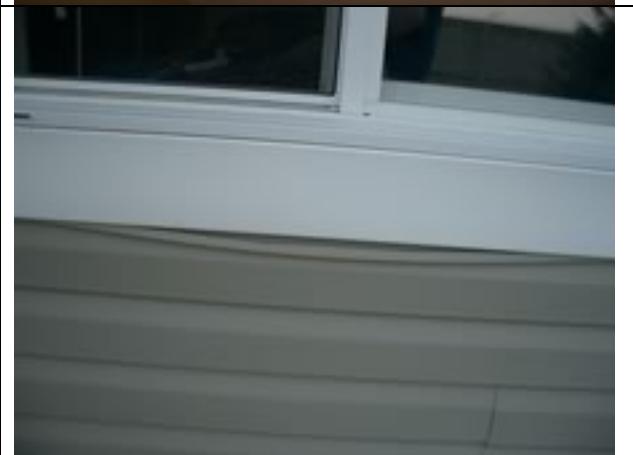
3000-M Item#44	<p>External Window gasket at unit 3107 hanging down.</p> <p><b>POV to Fix</b></p> <p>Update 05/28/2008 Not fixed.</p>

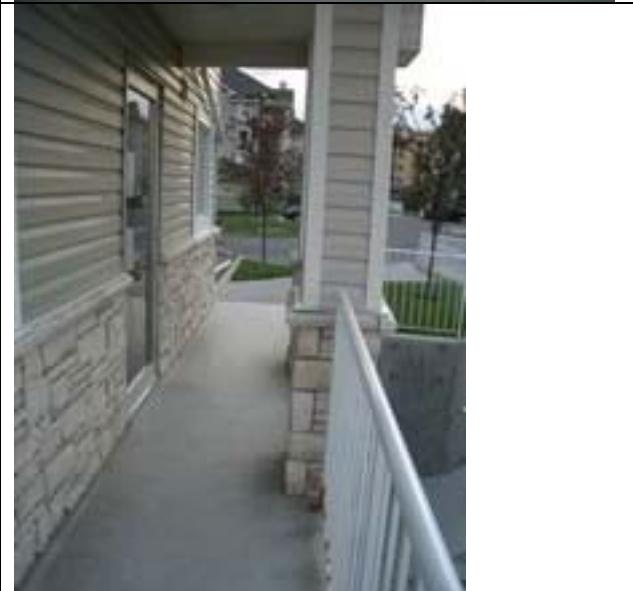
3000-M Item#45	<p>North exit door area above parkade vehicle entrance does not drain properly leaving standing water for days after a rain.</p> <p><b>Can't fix, building settling.</b></p> <p><b>BOARD Comments: Board needs to decide on acceptance of this item or not.</b></p> <p>Update 05/28/2008 Not fixed.</p>

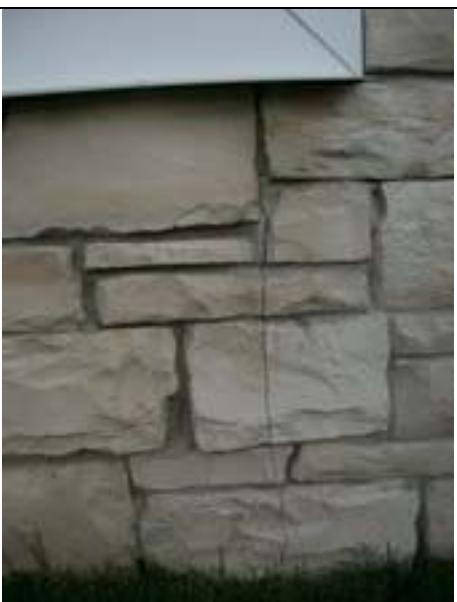
Location	Defect	Photographs
3000-M Item#46	<p>Crack on rock work below bedroom window of unit 3122 on exterior wall.</p> <p>No comment from POV</p> <p>Update 05/28/2008 Not fixed.</p>

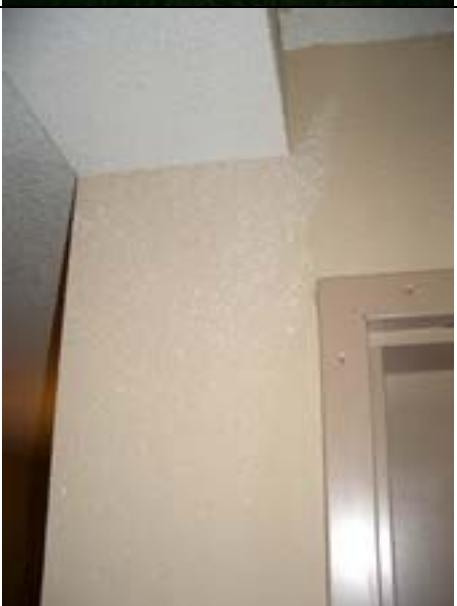
3000-M Item#50	<p>Stipple overspray during crack repair not painted, located in Main lobby 3000 next to Storage Room door.</p> <p>POV to Fix</p>

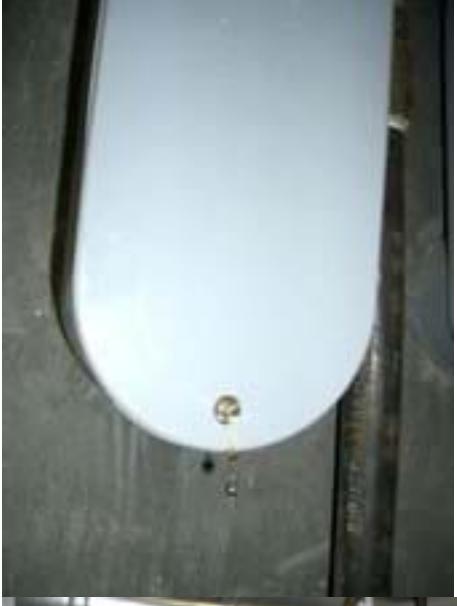
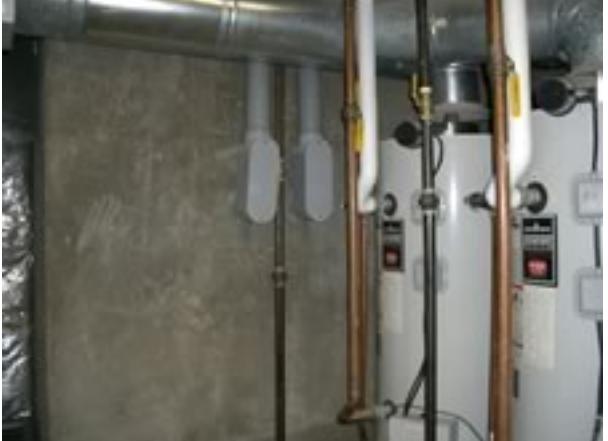
Location	Defect	Photographs
3000-P Item#52	<p>Water leak in Boiler Room from PVC junction next to water heaters. Originally reported very soon after occupancy. It was observed still leaking on July 31/07.</p> <p>Board to hire HVAC company to review/repair if necessary – bill POV.</p> <p>Board Comments: Board members did a little more investigation on this on Sept. 4 and partially removed the cover. A flood came pouring out, it appears this is open to outside wall and ground water is flowing directly into. We are not sure the purpose of this PVC and if POV can enlighten us it would us to understand this issue.</p> <p>23/10/07 POV Construction Manager advised this is not a HVAC issue. Board will not be hiring a HVAC Company to repair. He indicated this is a utility entrance for TELUS/SHAW and will have to be sealed properly so it's back in POV's hands.</p> <p>Update 05/28/2008 Not fixed. Leaking with spring rings, puddle on floor.</p>

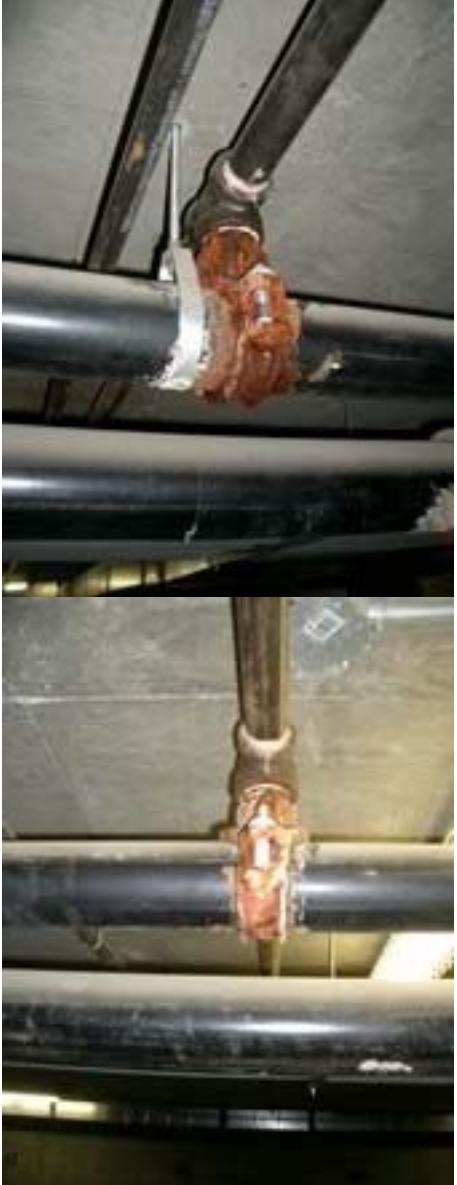
Location	Defect	Photographs
3000-P Item#54	<p>Fire Sprinkler Pipe Clamps slowly leaking and totally rusted in 2 cases on the main Fire Sprinkler water supply and must be replaced. They are located next between parking spots 65 &amp; 9, and 49 and 31.</p> <p>POV to Replace</p> <p>Update 05/28/2008</p> <p>Not fixed. Still leaking, sever rusting due to lack of action. Potential Fire control issue.</p>

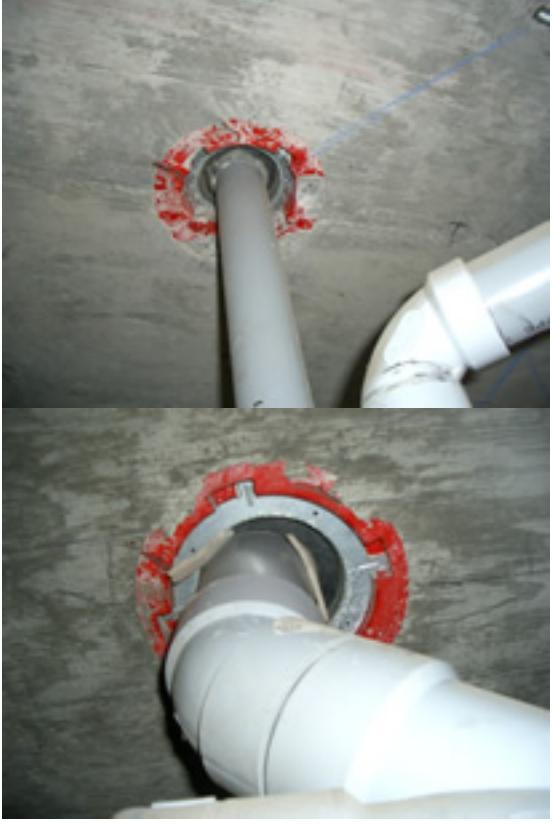
Location	Defect	Photographs
3000-P Item#55	<p>Fire rated protection missing from almost all piping penetrations in 3000 between the parkade and suites above. Fire rated compounds and Fire related sleeves are required.</p> <p><b>This is a serious code violation.</b></p> <p>Eng. Report issue FLS6 section 11.5.3</p> <p>POV Says O-Ring is sufficient.</p> <p>Update: Board will be having an engineer review. Board also notes numerous floor penetration have no protection at all.</p>

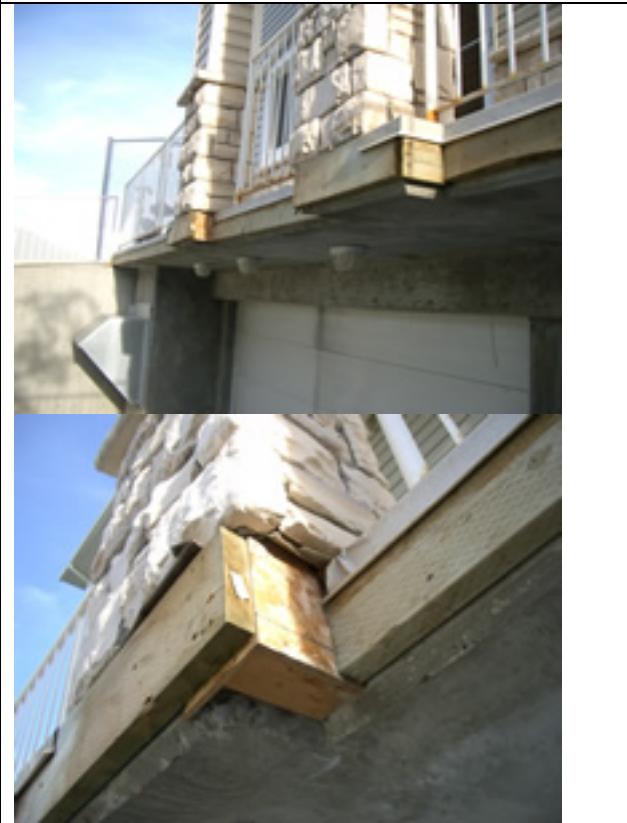
Location	Defect	Photographs
3000-P Item#58	<p>Above Parkade Entrance Fascia Wood unfinished and showing premature damage due to standing water. Wood should be stained or painted for protection.</p> <p><b>POV to Fix and match to Fence Color</b></p> <p>Update 05/28/2008 Not fixed. Exposed unprotected wood.</p>

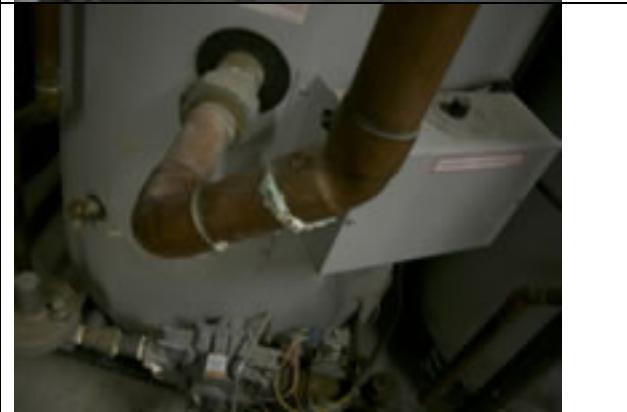
3000-P Item#73	<p>Hot Water Tank#2 Showing severe premature corrosion on Pipe Joint, suspect defective junction.</p> <p><b>Eng. Report issue M1</b></p> <p>Update 05/28/2008 Not fixed.</p>

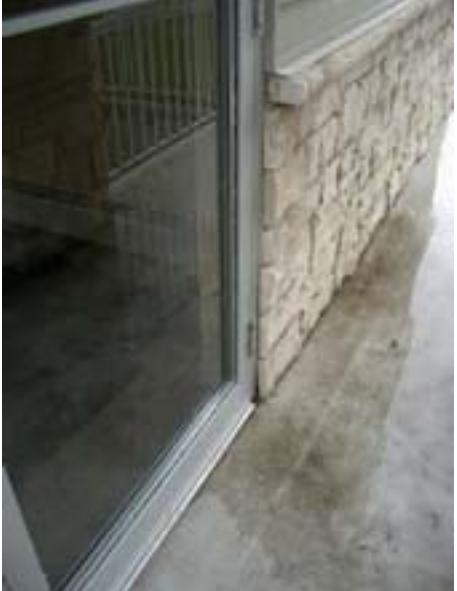
Location	Defect	Photographs
All Item#59	<p>All exterior doors are missing door stops resulting in damage to doors and numerous broken windows.</p> <p>POV to install</p> <p>23/10/07 The board notes the same of the doors have had door stops installed, and some have not. Some of stops installed notably on the side doors were installed in a manner that renders them useless.</p> <p>Update 05/28/2008 Only partially fixed. Many of them broke of the week they were installed. Some of them are two low to stop the doors.</p>

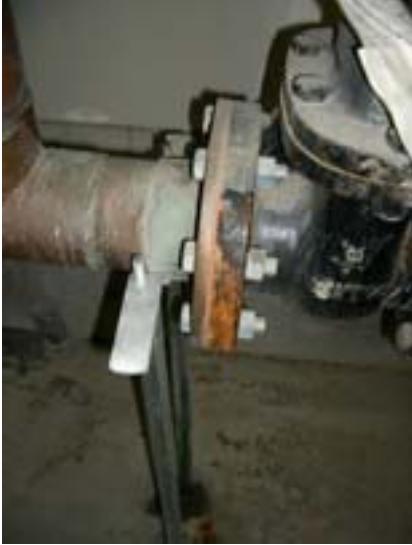
All Item#62	<p>Uninsulated cold water piping in boiler rooms is condensing and showing initial signs of deterioration and rusting.</p> <p><b>Eng. Report issue M1 section 9.1.1</b></p> <p><b>Checked on this 05/24/2008 and found mass condensation on all major cold water piping occurring in boiler rooms and the parkades.</b></p> <p>Update 05/28/2008 Not fixed. Severe Condensation on the cold water piping in the boiler rooms and parkade causing premature rusting.</p>

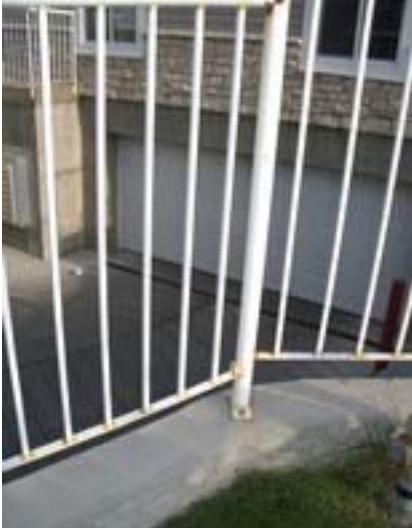
Location	Defect	Photographs
All Item#63	<p>Premature rusting of Parkade vehicle ramp railings. Broken welds appear to have fixed although the rail in this picture is loose due to missing screws.</p> <p><b>Eng. Report issue SF11 section 6.2.3</b></p> <p><b>POV to Fix</b></p> <p>Update 05/28/2008 Not fixed. All white railings throughout the project were experiencing severe rusting in the first year. POV had committed to paint all of them but has not yet delivered on that promise.</p>

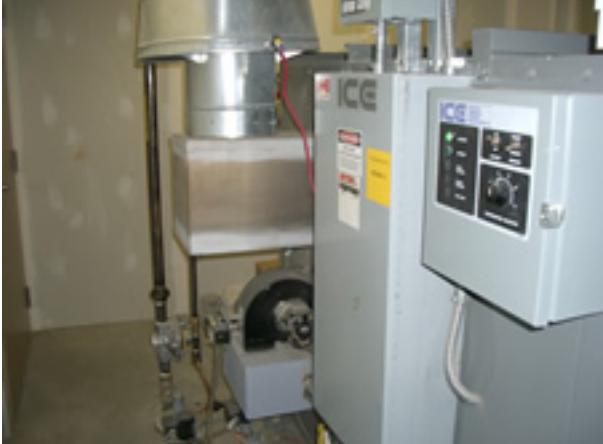
All Item#61	<p>Thermostats for Hallway Pressurization Units do not have sensors in the main floor hallways of each building resulting in a great deal of excessive heating in all 3 buildings (as advised by Concept Electric).</p> <p><b>POV to review w/engineer</b></p> <p>Update 05/28/2008 Not fixed. Promised report not received from POV.</p>
